Monitoring White Liquor Filter

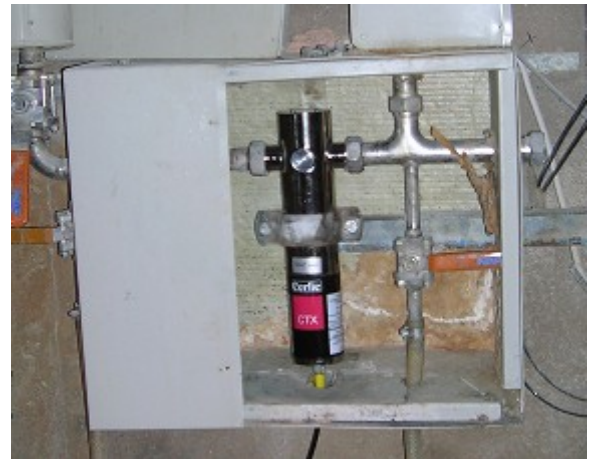
For continuous monitoring of the white liquor preparation, the Karlsborg mill, for many years, has used the Cerlic optical sensor for measuring the suspended solids after the white liquor filter. The first sensor was installed in the mid 90s and was exchanged in 2006 for the latest generation sensor CTX20/25-K. The sensor is installed on the pipe between the filter and the white liquor storage. The acid-proof sensor is for this special application having Kalrez-seals to cope with the aggressive liquor. The by-pass pipes to the sensor are insulated to maintain a high temperature (85-95°C) to reduce the tendency of deposits on the sensor windows. The sensor is removed once a month for manual cleaning with an acid solution.
