Monitoring White

Liquor Filter

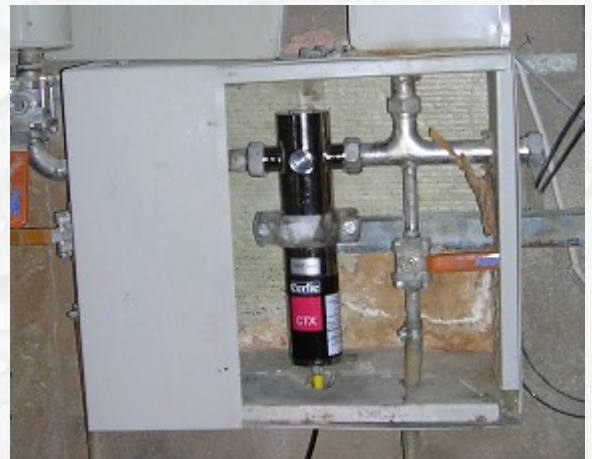
For continuous monitoring of the white liquor preparation, the Karlsborg mill, for many years, has used the Cerlic optical sensor for measuring the suspended solids after the white liquor filter. The first sensor was installed in the mid 90s and was exchanged in 2006 for the latest generation sensor CTX20/25-K. The sensor is installed on the pipe between the filter and the white liquor storage. The acid-proof sensor is for this special application having Kalrez-seals to cope with the aggressive liquor. The by-pass pipes to the sensor are insulated to maintain a high temperature (85-95°C) to reduce the tendency of deposits on the sensor windows. The sensor is removed once a month for manual cleaning with an acid solution.

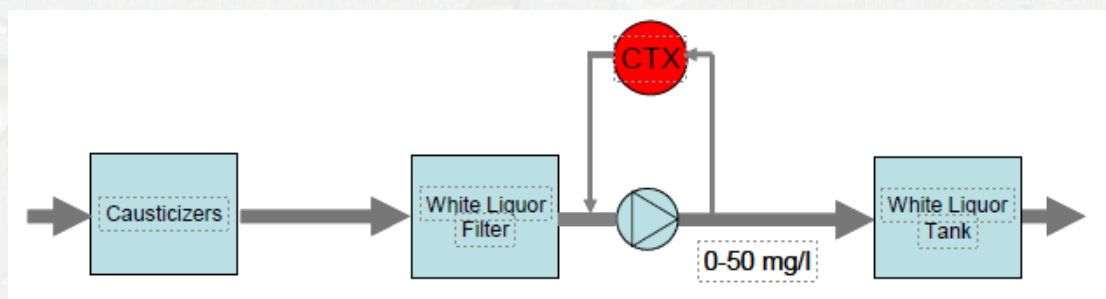
With continuous monitoring of the lime mud content after the white liquor filter, increased levels of solids due to damaged filter felts are quickly detected. With this information, the problem can quickly be fixed and consequently the upset condition in the digester and chemical recovery system is minimized.
